Fforwm Cerrig Cymru

Welsh Stone Forum

# NEWSLETTER

**Number 8 March 2011**

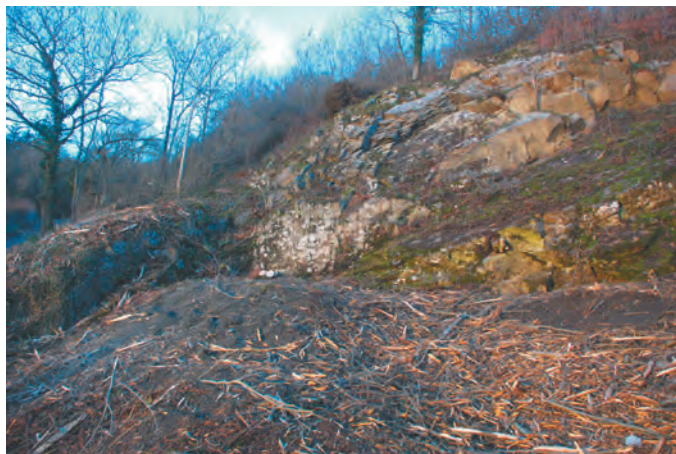
*Fig 1. Newmead Sandstone quarry.*

Recent work is revitalising sections of the Newmead Sandstone for study. The Newmead Sandstone was a vitally important building stone in Mid Wales. Its massive nature and relative ease of working meant it was highly valued. As a result its use stretches far beyond the area of outcrop, which is constrained to the western flanks of the Carneddau between Builth Wells and Llandrindod Wells. Many of the houses in the Builth area have been constructed of the stone, but

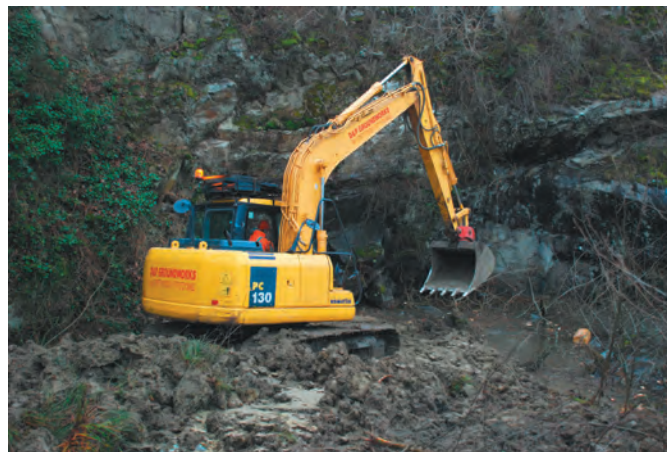
*Fig 2. Conservation work clearing exposures of Newmead Sandstone.*

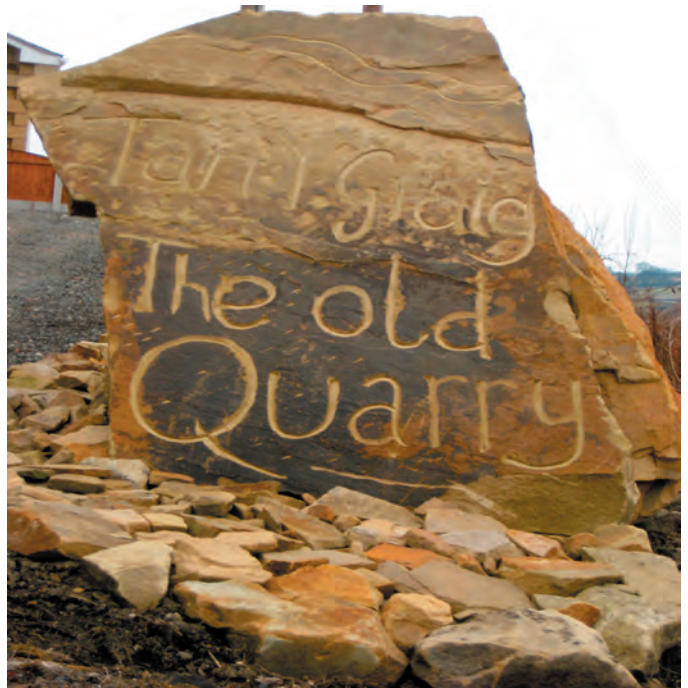
Fig 2. Tan y Graig Quarry, currently working Cefn Rock

Carboniferous rocks dominate the geology around the Pontcysyllte Aqueduct. In this area the 'Aqueduct Grit' (Namurian, Gwespysr Formation) has a faulted contact with the Cefn Rock (Coal Measures, Bettisfield Formation). The Cefn Rock is a pale yellow, massive, quartz-rich sheet sandstone, up to 37m thick, which is still quarried today. It was deposited in a deltaic environment, about 325 million years ago, when Wales was on the edge of a large continent in the southern hemisphere. It forms several roughly N-S trending fault-bounded ridges that have been extensively quarried, as shown by the series of quarries above the aqueduct in the village of Cefn Mawr.

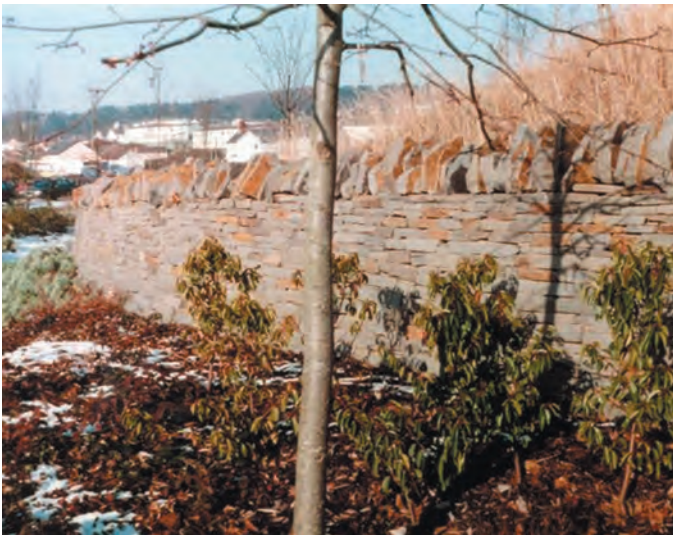
*Fig 5. Merthyr Tydfil : before*

The Merthyr walls for which I was responsible at the same time have fared little better than those at

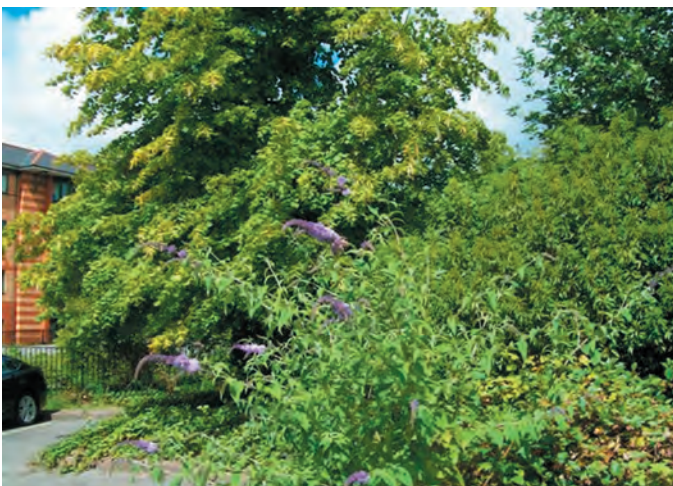
*Fig 6. Merthyr Tydfil : after*

Has the money really been well spent? The maintenance issue has certainly been learnt. Wallers tell me that there is always a 12 month maintenance

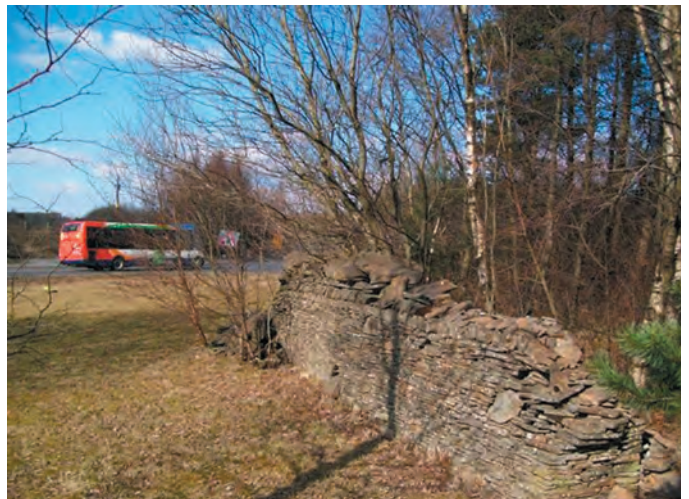
*Fig 7. Hirwaun roundabout*

in a very prominent position, on a roundabout on the important Heads of the Valleys trunk road, that are meant to be a proud statement seen by those driving by. The combination of bad workmanship and lack of maintenance has left a sorry sight. [Fig. 7]. The present County Borough Council is not, needless to say, the Council who originally commissioned the wall.

All councils nowadays, I think very properly, demand that wallers should hold a Higher Certification from the Dry Stone Walling Association. However, in the 1980s and early 1990s some walls were built by unskilled wallers who were competent at mortared walls but had no training, let alone certification, in dry stone walling. An example is a quartet of walls,

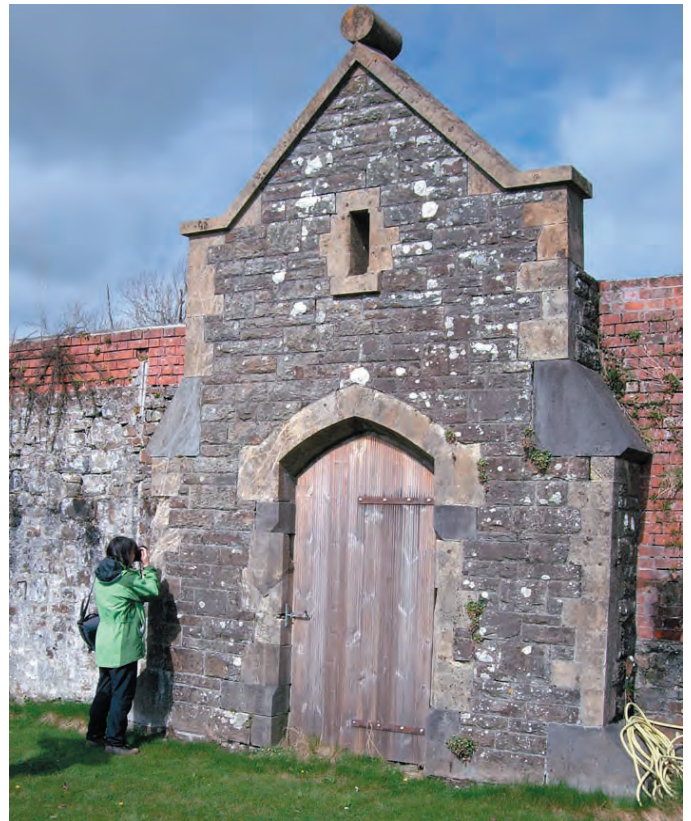
*Fig 2. The gate between the Abbey and gardens.*

An imposing Victorian gate separates the Abbey from the garden area [Fig 2]. It is built of local gritty sandstone and dressed with Bath Stone and Carboniferous Limestone. Although the sandstone and the Carboniferous Limestone were holding up well some of the Bath Stone dressings were beginning to fail.

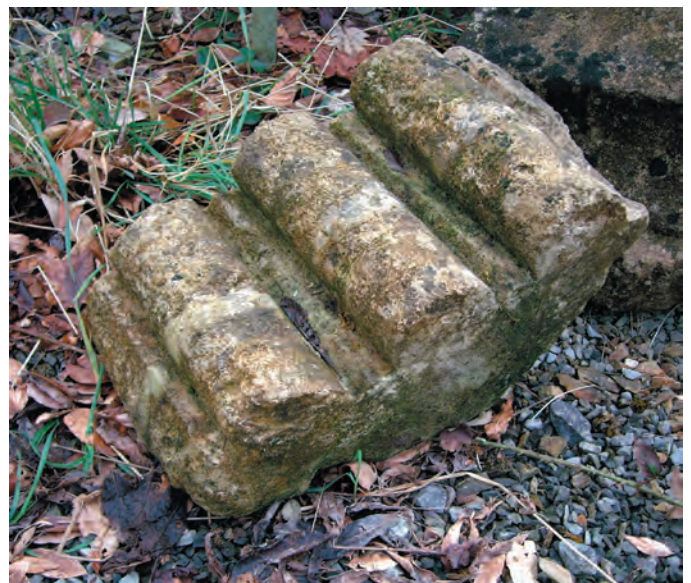
*Fig 3. C13th worked Dundry Stone*

As was normal practice the builders had re-used masonry, probably from the Abbey site, to construct the farm buildings and we found re-used Dundry and Sutton Stone limestones at the farm. Closer inspection of the Dundry Stone revealed the presence of fossil crinoids. At the back of the house there were a number of pieces of limestone dressed in C13<sup>th</sup> style and closer inspection proved to be Dundry Stone [Fig 3]. This caused some consternation as there was no known documentary evidence of a C13<sup>th</sup> rebuild. John Davies suggested that this may have been work of the Welsh Princes rather than the Marcher Lords as the activities of the Welsh Princes tend to lack documentary evidence. It was possible that use of different stone at the Abbey may be related to changing political affiliations over time.

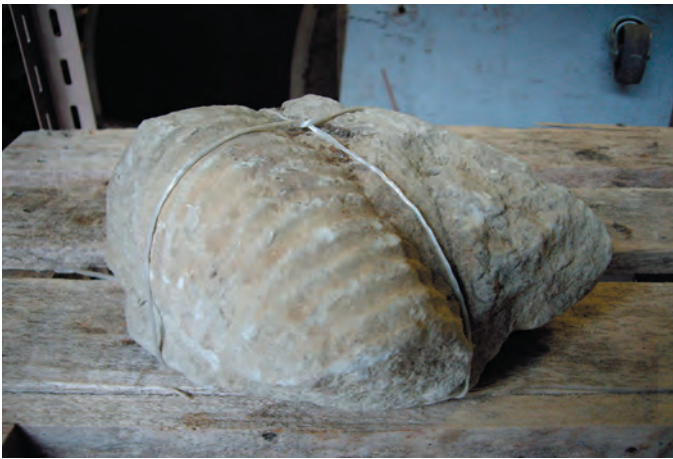
Fig 4. An ammonite in Chilmark Stone.

Most of the dressed stone used at Whitland is Dundry Stone. However, we were shown a large fossil ammonite [Fig 4] that came from the excavation and, following inspection, Tim Palmer thought that the stone in which it was contained was probably Chilmark Stone, an Upper Jurassic (Portlandian) limestone used in the construction of Salisbury Cathedral. It was anybody's guess how that got there. Another find from the re-excavations was a stone that was possibly Quarr Stone, a stone from the Oligocene, Bembridge Limestone Formation from the Isle of White [Fig 5]. It was this stone that was used in the upper sections of the White Tower at the Tower of London. Following a long day that probably posed more questions than answers the meeting finished and we went our separate ways at 4.15 pm.

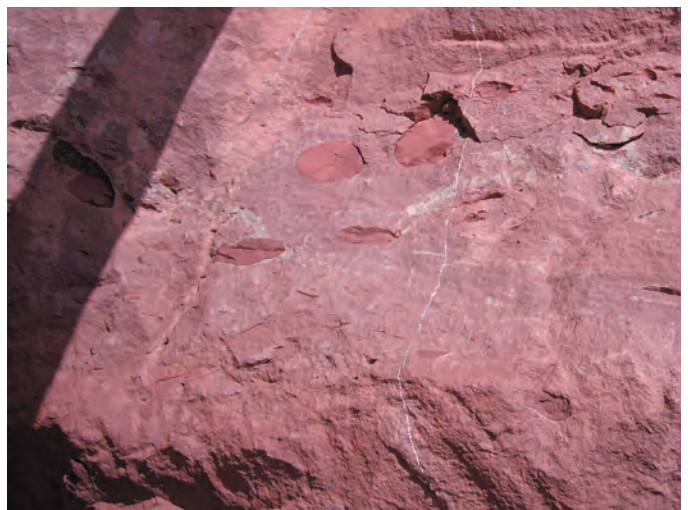
Fig 2. Mud clasts in Old Red Sandstone.

Examination of the beds in the quarry showed that the beds of stone started off gritty and coarse at the bottom and fined upwards through the bed. John and Jana explained how these rocks had been deposited in channels on a muddy flood plain where flowing water would rip up the channel bed and re-deposit the material further along the channel. The heaviest particles would fall out of suspension first, creating coarse gritty layers at the bottom, and then fine upwards into a muddy layer. This process would repeat itself over and over again. Inspecting the large blocks of stone in the quarry we found some with ripples on the underside, further evidence of the action of running water. Much of the stone left lying in blocks was useless as dimensional stone due to the

inclusion of mudstone clasts [Fig 2] and mud-filled burrows. At the top of the quarry the beds became very flaggy.

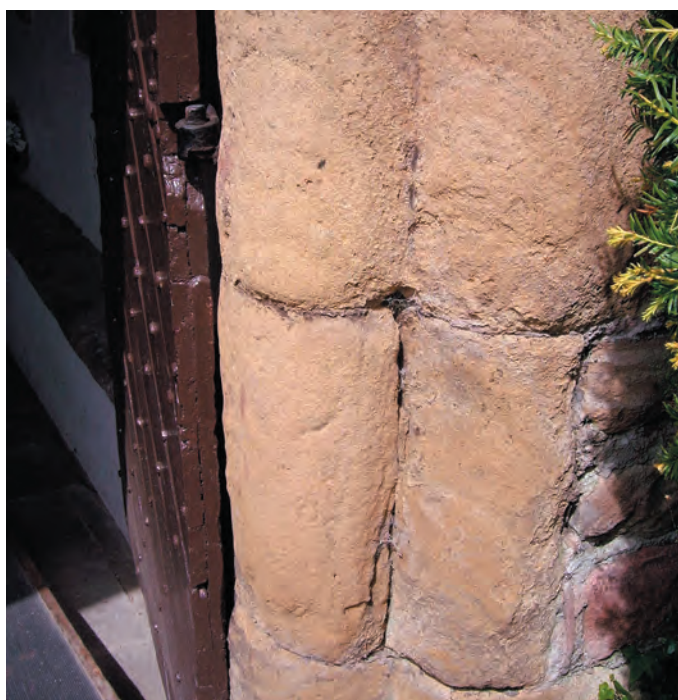
*Fig 4. Unknown yellow sandstone in the porch at St. Michael's church.*

The church building [Fig 3] has undergone many changes over the years. The current building was started in the C14<sup>th</sup> and much altered and extended in the C15<sup>th</sup>. The stone used during the Medieval construction phases was mostly Old Red Sandstone from the Tintern and the Mitcheldean areas, but Carboniferous Limestone had also been used. Extensive restoration took place in the C19<sup>th</sup> which included the fitting of new Bath Stone windows. Inside the church we found carvings in Carrara Marble while a yellow sandstone of unknown origin was spotted in the porch [Fig 4]. This might have been Sudbrook Sandstone but could have been Tintern Sandstone as there are some yellowish local outcrops in the Tintern area. However, its provenance could not be confirmed.

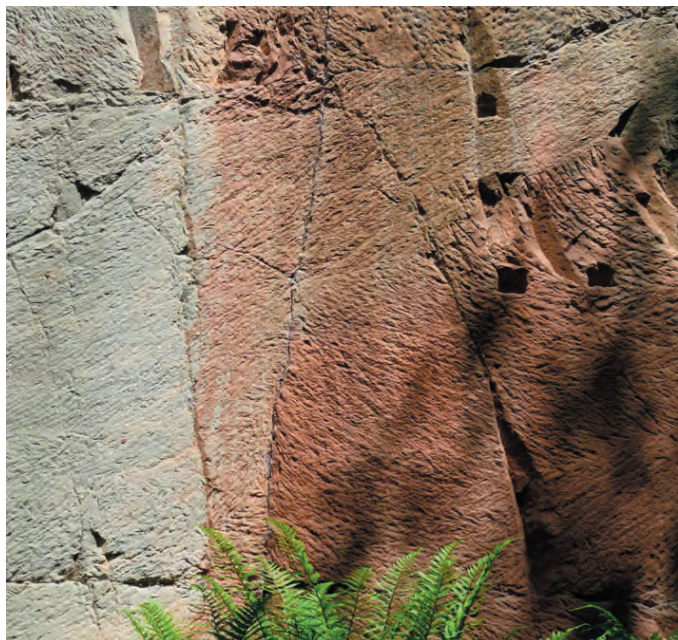
Fig 2. Bridge Quarry showing numerous tool marks in the sandstone. Note also the variation in colour of the sandstone produced by removal of iron.

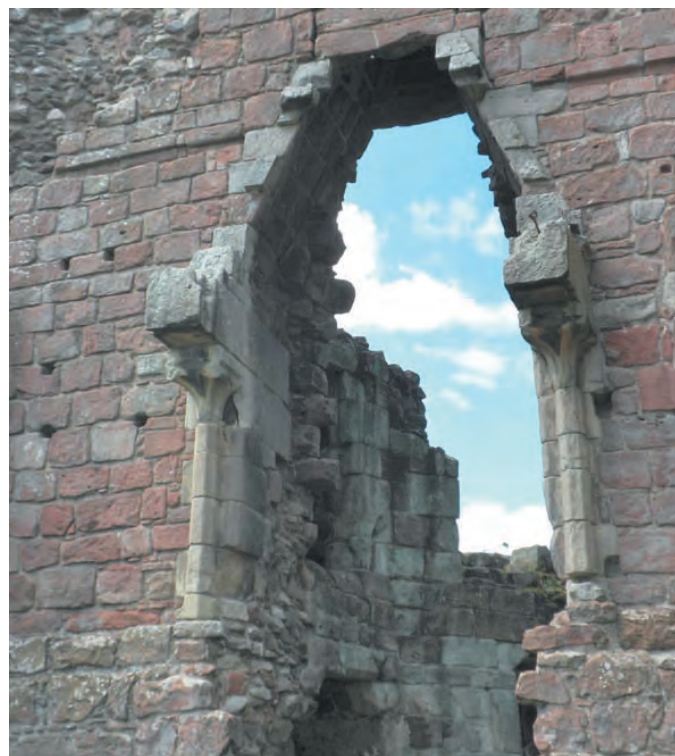
Fig 3. Morton Corbet Castle, thin pink Grinshill Sandstone facing with rubble stone behind.

The mediaeval castle is largely built of pink Grinshill Stone, carefully coursed as an outer layer, with rubble masonry behind as one would expect for this period [Fig 3]. The finer elements, such as pilasters with foliate capitals, are in grey Grinshill and the gatehouse is also in grey Grinshill, this time ashlar faced, suggesting that this might be part of a late mediaeval (c.1400?) build. Some interior features, from their style and inscribed date or initials, appear to comprise the Elizabethan modernisation of the mediaeval fabric, and seem to be simply added to it.

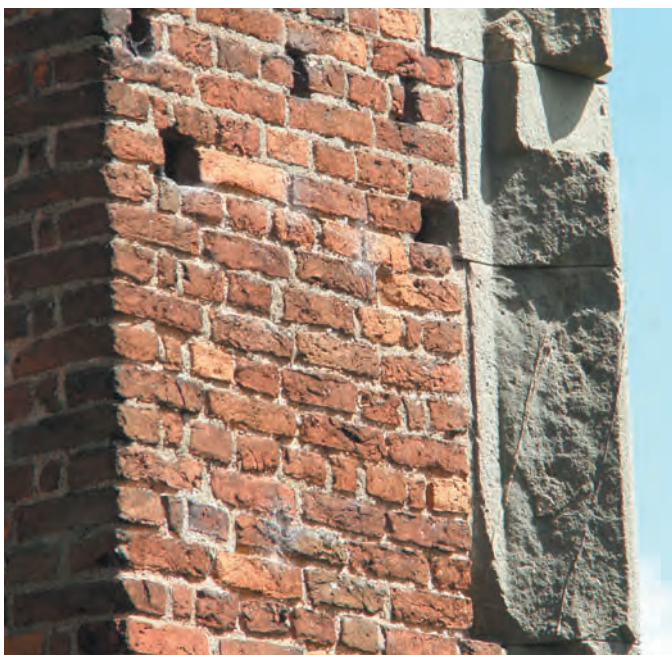
Fig 4. Morton Corbet Castle. Elizabethan outer skin of Grinshill stone with load-bearing brick structure behind.

The Elizabethan build provoked more interest as here the socially ambitious Corbets, while creating one of the most up-to-date exteriors in the land, with finely carved ornamentation, only used Grinshill Stone for a relatively thin outer skin (the main load-bearing structure being provided by brick) [Fig 4] and as the freestone for the carved elements, despite owning the quarry. The delicacy of the decorative carving demonstrates Grinshill's high quality as a freestone. However, it exhibits differential weathering, which is probably linked to orientation.

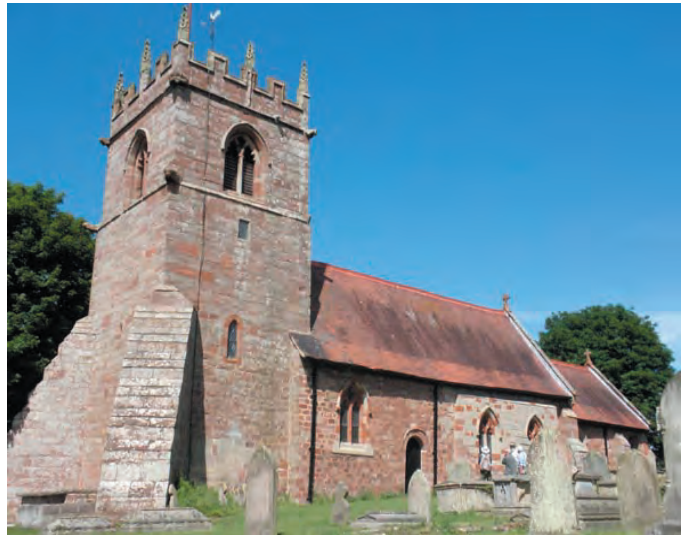
Fig 5. Gargantuan buttresses, St Andrew, Stanton-upon-Hine Heath.

The next stop was St Andrew's [Fig 5] in the nearby village of Stanton-upon-Hine-Heath. This is a village almost entirely built in local red brick, reflecting the local availability of clay within the Cheshire/north Shropshire basin and suggesting why Moreton

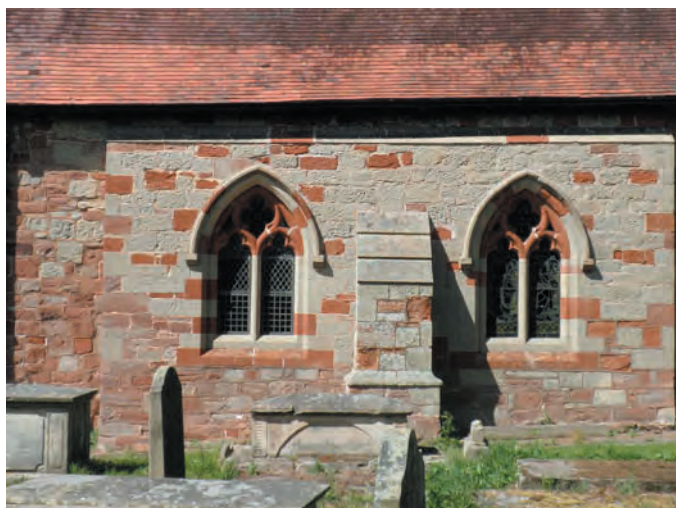
*Fig 6. St Andrew, Stanton-upon-Hine Heath. Close up of patchwork white and red Grinshill Sandstone in buttress.*

(eastern half of nave) [Fig 6], as this stood proud and was in finer ashlar but more patchwork-like in its use of pink and white stone, which continued into rather haphazardly stripy windows! Inside we discovered that this was due to the south aisle being in-filled (no published source seems prepared to suggest when, but onsite inspection suggests that the C19<sup>th</sup> restoration is the most likely cause). The way in which this section alone stood so proud of the rest of the south façade remained a bit puzzling, as did the 'patchwork' character. Had it not been such fine ashlar one might suspect that it had been intended to be rendered (perhaps this indicates a local taste for such contrasting masonry).

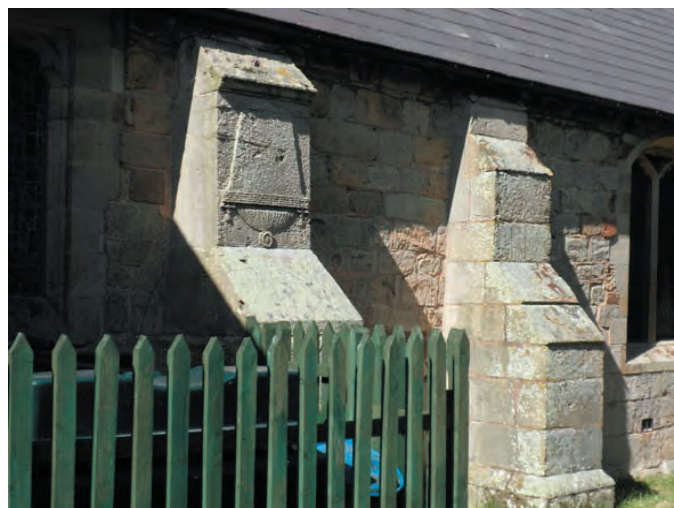
*Fig 7. St Mary's church, Shawbury. Buttress with part of a reused or unfinished gravestone.*

The final stop for most members was St Mary's Church, Shawbury, another Grinshill Stone build begun in the Norman period (with chunky doorways, at least one of which had been reset later) in coarsed, mainly pink stone, but with later additions, notably a later mediaeval tower of fine ashlar in grey sandstone. Again, it was the south elevation that supplied puzzles, this time in one of the buttresses. All of these are grey ashlar and had later additions, presumably a response to walls tipping out under the weight of the rather large stone-flagged roof. At first sight one of these [Fig 7] seemed to be a reused gravestone, but the depth of the stone seemed too great for this. Suggestions please!

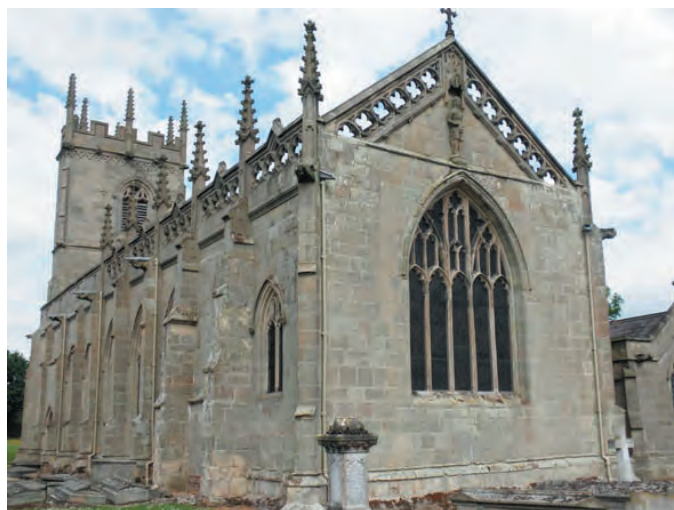
*Fig 8. St Mary Magdalene, Battlefield. Eroded patches of stonework, view north.*

of erosion [Fig 9]. Various patches in the exterior stood out as being particularly eroded [Fig 8] and much discussion ensued as to why some parts were worse than others, as neither date nor orientation seemed to supply an answer; personally I think the

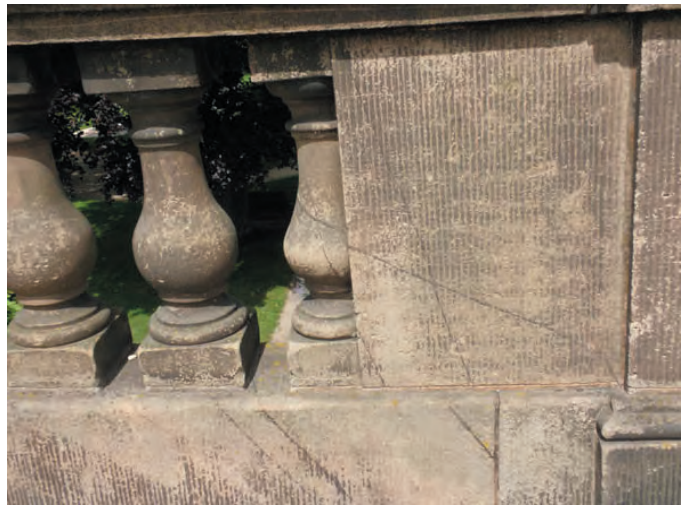
*Fig 11. English Bridge, Shrewsbury.*

sporadic presence of cement mortar can provide the explanation. Having found the church in a fairly ruinous state in c.1860 Pountney Smith completely renewed the frieze, battlements and pinnacles around the top of the walls, and despite these being the most exposed elements they show no sign of serious erosion [Fig 10] ... nor of cement mortar! From here we forayed forth to Shrewsbury where a glance at the bright red Abbey, opposite the car park, made clear that here Grinshill was competing with another more local, and less resistant sandstone. Our first, brief, halt was on the English Bridge (John Gwynne, 1769-74), offering a splendid example of archetypical (grey) Grinshill Stone [Fig 11]. From here we looked across

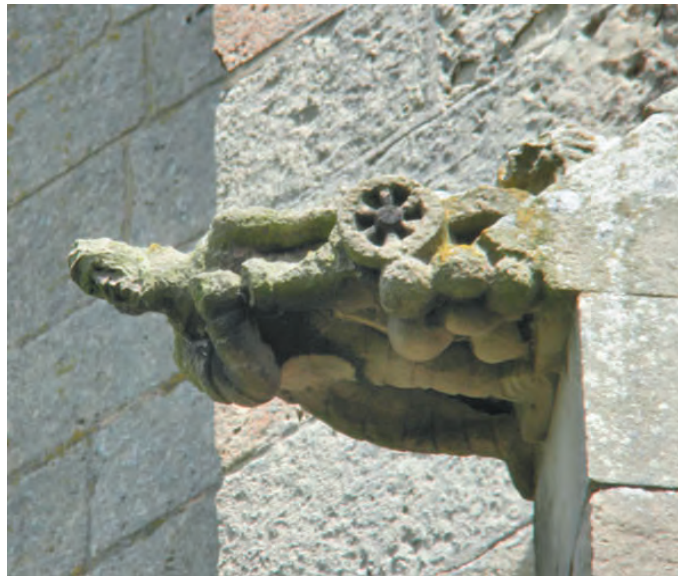
*Fig 9. Gargoyle, St Mary Magdalene*

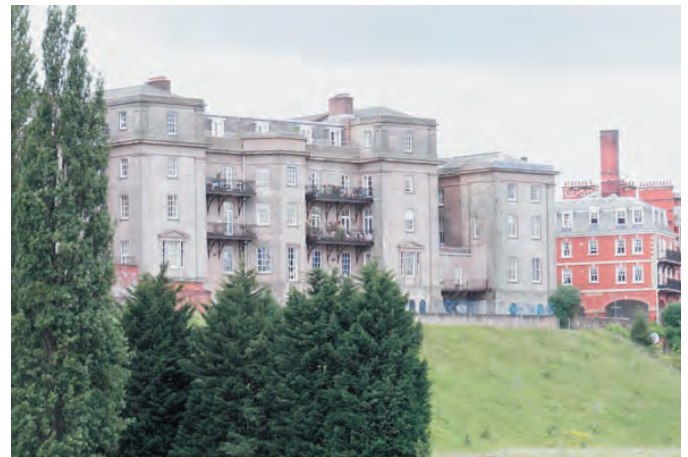
*Fig 12. Old Royal Salop Infirmary, now the Parade Shopping Centre, with flats above.*

the Severn and up to the old Royal Salop Infirmary, the first of several fine early C19th civic buildings in grey Grinshill ashlar designed by our Treasurer's namesake, Edward Haycock (1827-30). These have now been converted to the Parade Shopping Centre, with flats above by Arrol & Snell, (1980-83) [Fig 12].

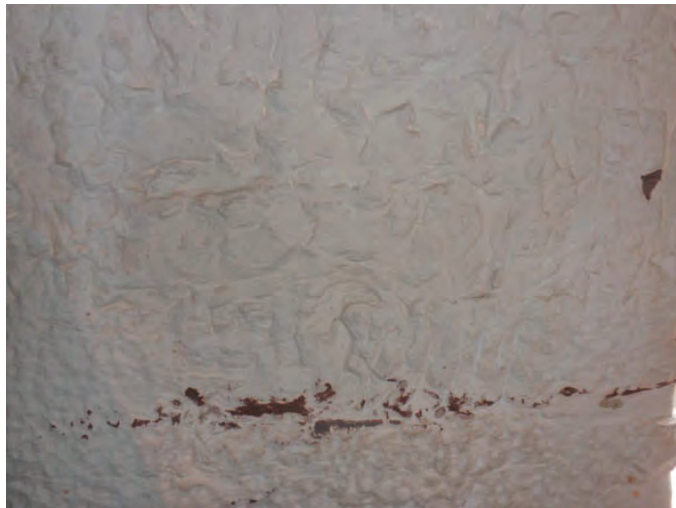
*Fig 13. Internal wall of the Old Market Hall showing the use of local red sandstone.*

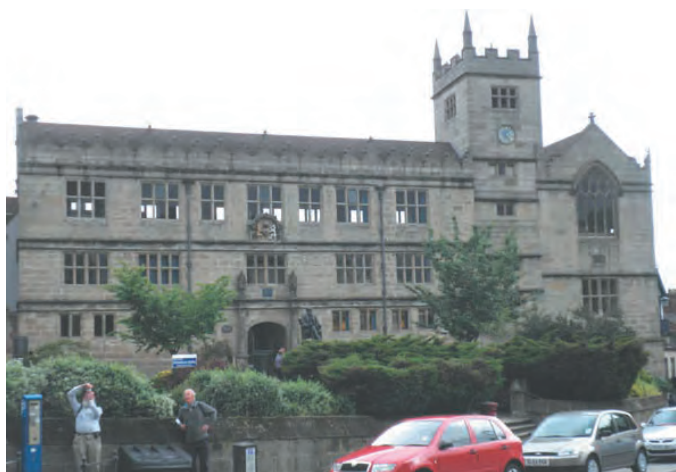
*Fig 14. Old Shrewsbury School.*

Our next stop, Old Shrewsbury School (1595-1630, now Shrewsbury Library) with alterations by Edward Haycock (1815) [Fig 14] provided a useful comparison as, although much larger than the Market Hall, is almost exactly contemporary and was commissioned by the same client. We therefore suspected that here too the fine ashlar exterior might be less solid than it appeared, and might again be a facing to a structure largely built of cheaper local

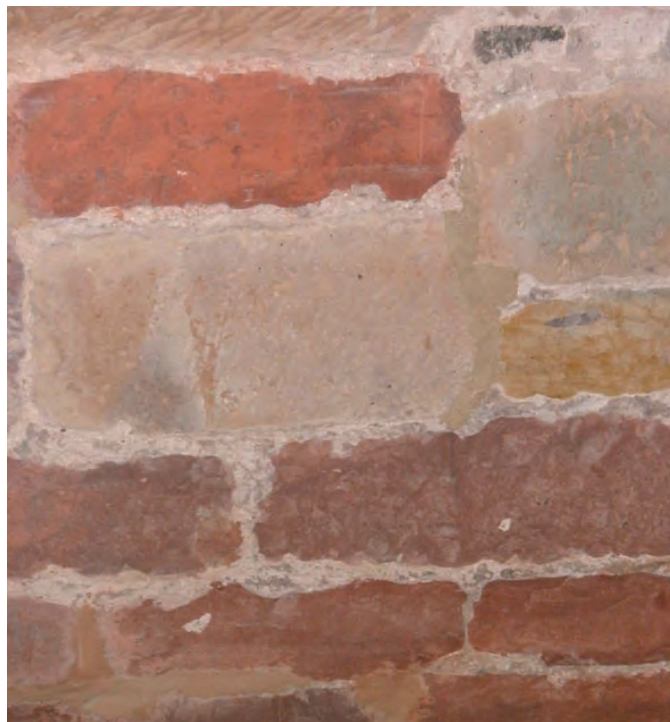
*Fig 15. Internal wall of Old Shrewsbury School showing construction from rough coursed local stone.*

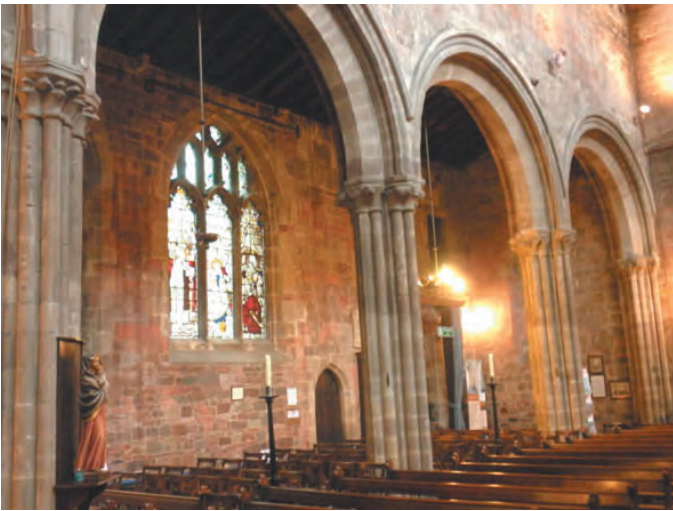
Fig 16. *St Mary's Church, Shrewsbury, with contrasting stone in the walling and arcade.*

Inside the quality of the grey Grinshill Stone used for the arcade contrasts rather dramatically with the external wall, which is as random inside as it was out [Fig 16]. Part of the wall is still covered with plasterwork imprinted with a mould (think wallpaper in plaster) [Fig 17]. The warden (rather knowledgeable, as this is in the care of Churches Conservation Trust) claimed that it had always been like this, and while the current plaster looked to me like C19<sup>th</sup> restoration. I think it possible that it had always been plastered over since the stone beneath is such a 'dog's dinner' that it hardly matches the standing of this church. It therefore seems likely that this walling stone might at least in part come from the same source as the internal stone used in the Market Hall and Old Shrewsbury School, i.e. the nearby Quarry. This suggests that further research into patronage of individual buildings could be revealing, as it is striking that this major parish church (the largest in town at the time of erection) had less ready access to the higher quality stone of the Grinshill quarries than did the civic buildings of Market Hall and School later on.

Finally, we arrived at St Mary's Church (Late Norman through to late C13<sup>th</sup>), supposedly of grey Grinshill outside although with a C19<sup>th</sup> tower in red sandstone, replacing that which had fallen into, and largely destroyed, the nave. This is now the most prestigious church in the town centre, albeit due in part to the outstanding collection of continental mediaeval stained glass (a C19<sup>th</sup> vicar here was an ardent collector!) and rather wonderful angel roof (part of the C19<sup>th</sup> repairs), which even the most devoted geologists could hardly ignore! However, its exterior is getting on for 'Elmer the elephant' style, i.e. patchwork quilt in stone, which made us wonder whether it had originally been rendered. Before we could decide on this John fatally stated 'Well, we

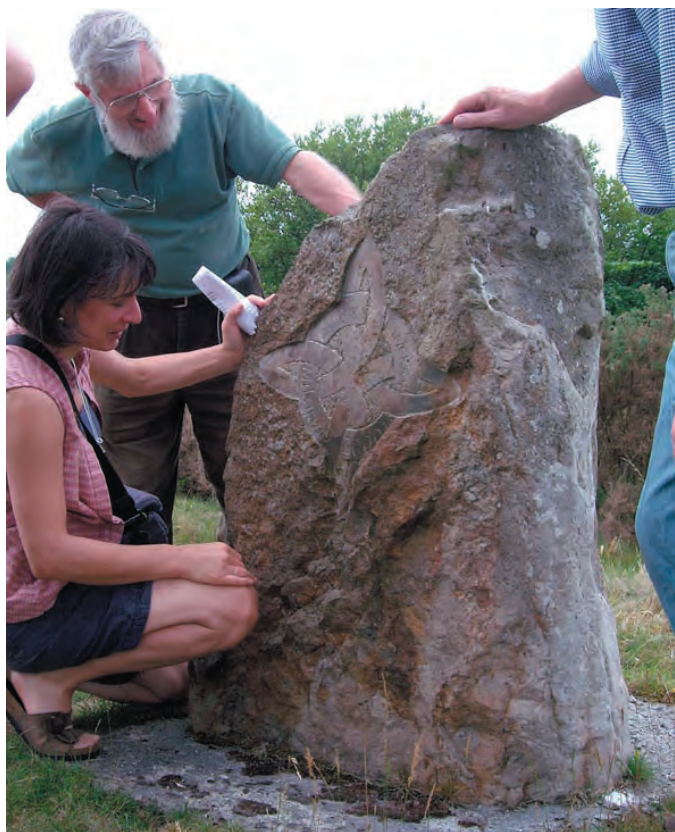
*Fig 1. Jana & John at the Millennium Rock*

Leaving the river, members found a number of large pieces of stone lining the road, the majority of which were conglomerate, some showing where calcrete inclusions had weathered out. However, two stones were different. One, the Millennium Rock [Fig 1], was thought to be Namurian, Basal Grit; the other an Old Red Sandstone with a plaque commemorating the 125<sup>th</sup> anniversary of a horse race first ran at Llangadog in 1884.

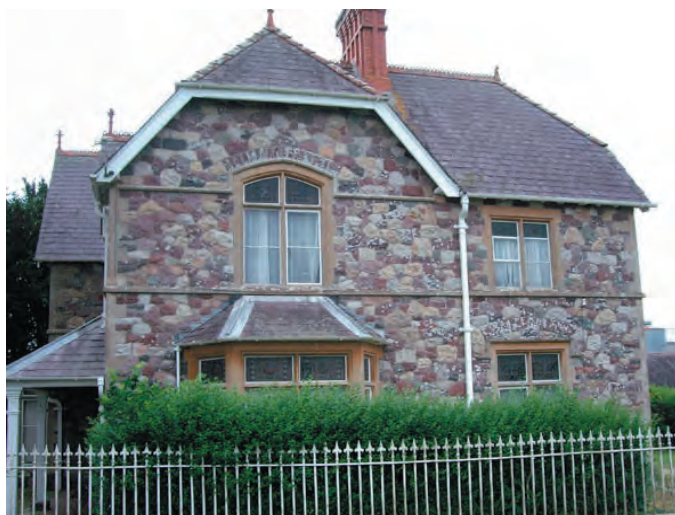
*Fig 2. Farmhouse of Sawdde cobbles.*

Nearby a farm house had been well built using stone cobbles from the Sawdde, the fronts of which had been dressed-off to create a relatively flat surface [Fig 2]. The dressings and quoins were of a Jurassic limestone which Tim Palmer later identified as Bath Stone. Out buildings at the rear were also built using the local cobbles. However, the barn had quoins that may have come from the Black Cock Formation and a later extension, possibly a garage, had red brick

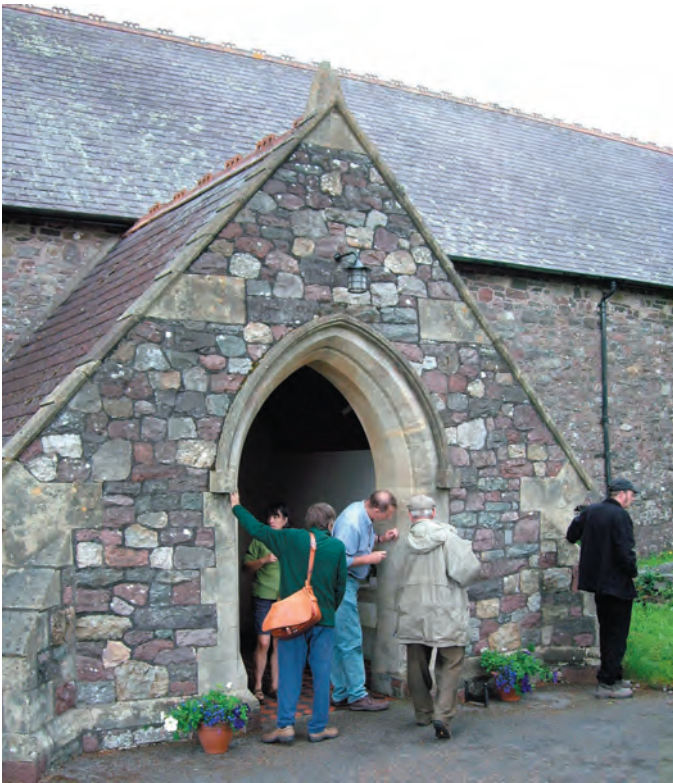
*Fig 4. The porch of St Cadog's church*

After lunch, led by Vince Quatermaine, we set off to view the stone used in the buildings of Llangadog. The Red Lion was well built in stone from the Black Cock Formation and had fine lime mortar joints. The threshold was a dark Carboniferous limestone exhibiting a nice fossil orthocone. Reaching the Church of St Cadog we found the perimeter wall was built of a Namurian, Basal Grit, which probably came from the top of the Black Mountain. The piers and coping were of Carboniferous Limestone. The medieval Church of St Cadog has been much altered over the years and I understand that it was almost totally rebuilt at the end of the C19<sup>th</sup>. The porch, which may well have been added at that time, was built using stone from the Sawdde and Box Ground Bath Stone dressings [Fig 4].

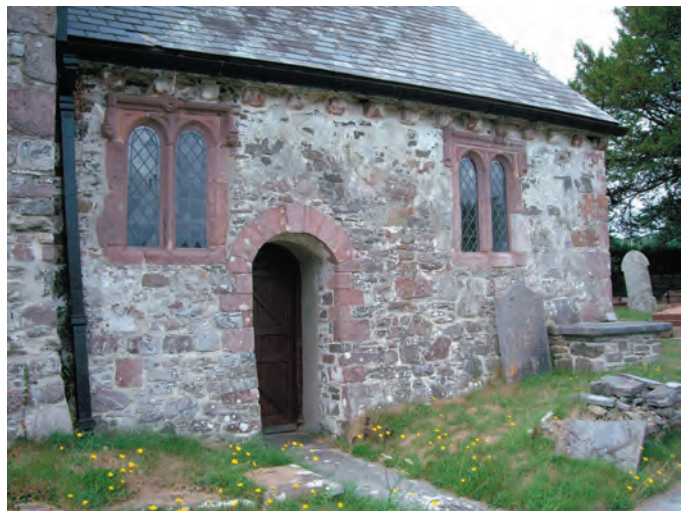
*Fig 5. Myddfai Church*

The last visit of the day was to the medieval Church of St Michael at Myddfai [Fig 5]. It is thought that the church building was built in two stages; the south nave and chancel in the C13<sup>th</sup> and C14<sup>th</sup> and the north aisle added later in the C15<sup>th</sup>. Two major phases of restoration have taken place. The first, between 1868 and 1880, included the addition of two new windows to the west wall and the second, in 1926,

when the Vestry was re-roofed. The main building material was sandstone from the Silurian, Wenlock Formation, with the quoin stones and other dressings to windows and doors of pebbly Brownstones. Inside the church the columns and arches were also of pebbly Brownstones. Over the years successive repair work has seen other stone dressings added and

you can now see Carboniferous, Pennant Sandstone window mullions and Bath Stone dressings. In the north wall of the vestry, there are recent window replacements in a red sandstone, probably of Triassic age, which might possibly be Hollington Stone from the Midlands.

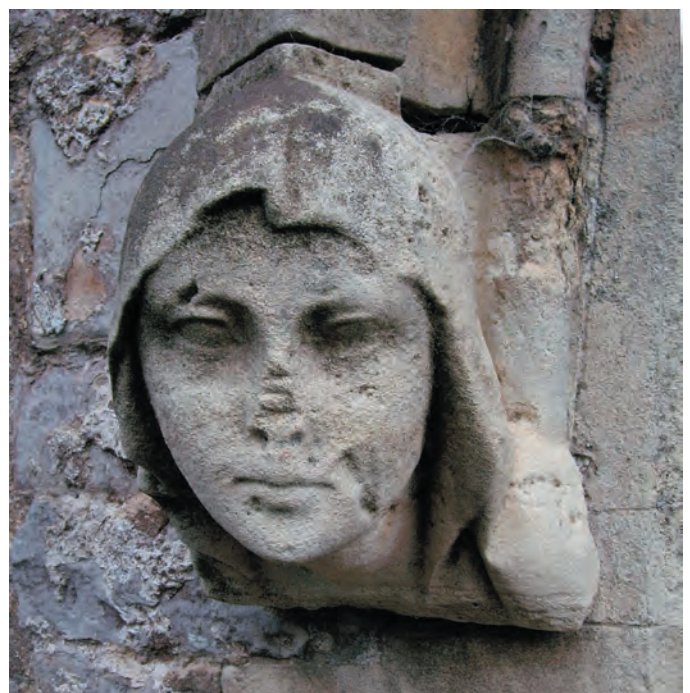
*Fig 3. Dundry Stone, St Mary’s Church.*

After lunch we visited St Mary’s Church at Caldicot [ST 483 886]. This church, built in the early C12<sup>th</sup> and extended in the C14<sup>th</sup> and C15<sup>th</sup>, sits on the site of an earlier church. The late medieval south porch was faced with Dundry Stone limestone ashlar [Fig 3] but later repairs had been carried out using Bath Stone with Sudbrook Sandstone being used for the sides. Inside the porch there were fine heads carved in Dundry Stone.

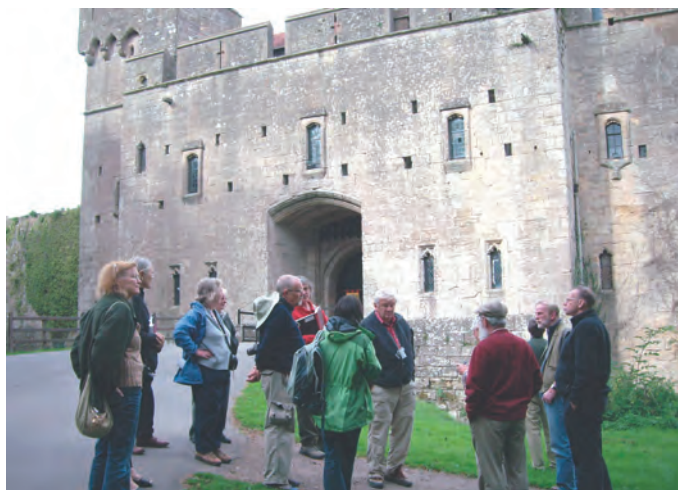
Fig 4. Caldicot Castle

consisted of a round stone keep built around 1221, with subsequent work continuing at various times up to the end of the C14<sup>th</sup>. We assembled outside the imposing south gate, which along with the adjoining curtain wall, was built mostly of blocks of Sudbrook Sandstone.

There was some debate as to the origin of this stone due to the method of construction of the wall. Here some large blocks had been laid in courses above much smaller blocks, which is not an ideal method of construction. I would suggest that this stone would not normally have been used unless a previously unavailable deeper bed was quarried or if the stone had come from the demolition of existing structures and the stone was laid as it arrived on the carts. A similar style of construction can be observed at Beaumaris Castle. J R L Allen writes in his paper that the robbing of stone from the Roman site at Caerwent would not provide the volume required for the construction of Caldicot Castle and suggests a possible quarry site south west of Sudbrook Point as the source but this does not explain the unusual method of construction.

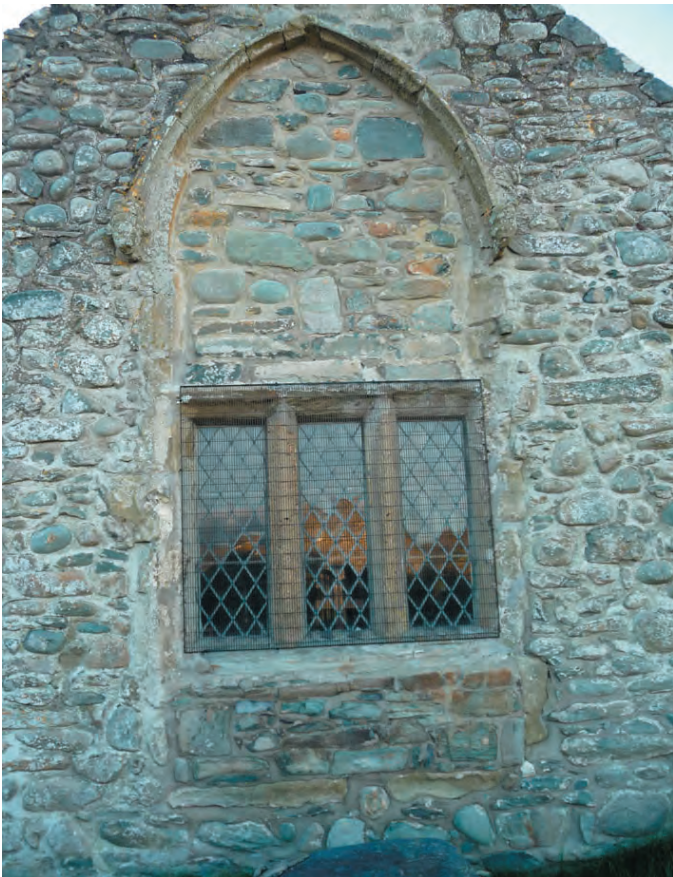
Fig 1. East window of St. Tanwg's Church, Llandanwg.

The east window is gothic although only the incomplete chamfered surround remains [Fig 1]. The hood mould is terminated on either side with two carved heads. The head on the south side is that of a crowned monarch, whilst the one on the north looks female. Both are very weathered. All dressings and carving is worked in yellow Egryn Freestone (see WSF Newsletters 1 and 4 for more details of this lithology) although two blocks of the windowsill remain in place.
