# NEWSLETTER

**Number 11 March 2014**

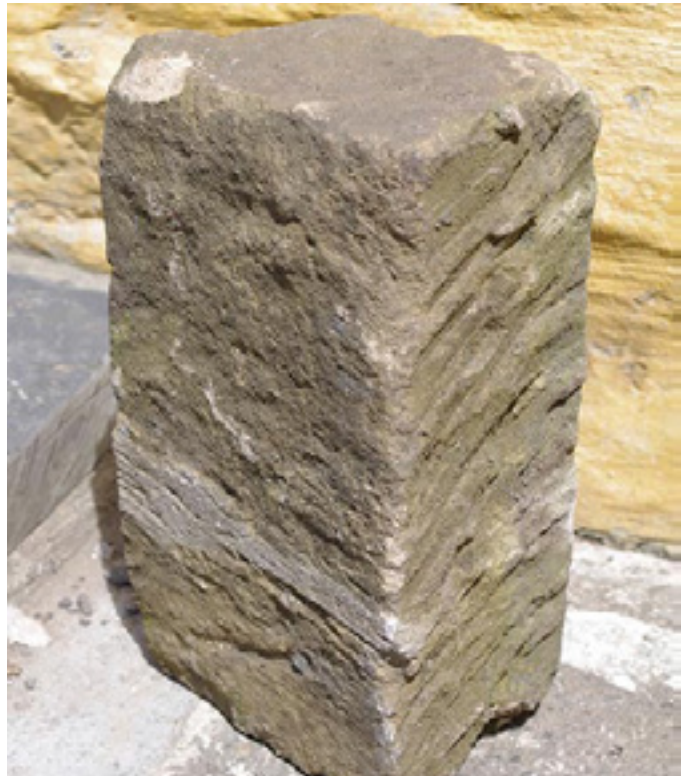
*Fig.1. (Above) Dundry and Sutton Stone cills, Cardigan Castle.*

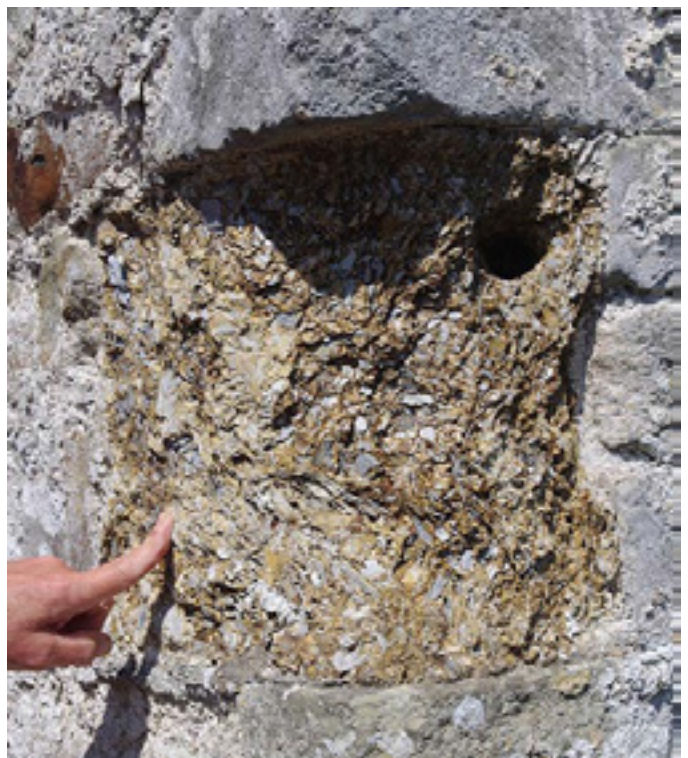
*Fig.2. (Top right) A medieval dressed block of Dundry Stone, Cardigan castle*

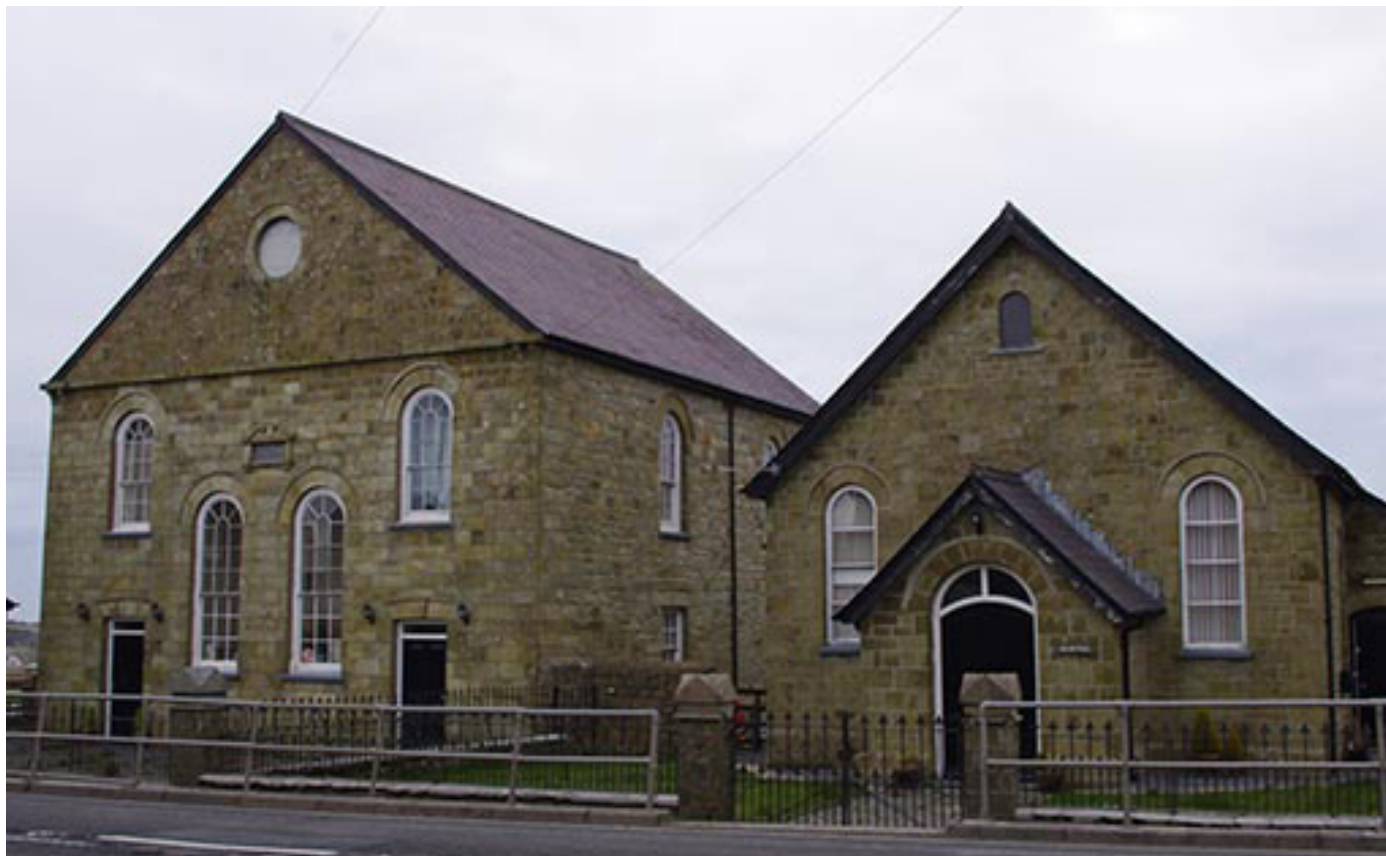
*Fig.1. (Top) Tanygroes Calvinistic Methodist Chapel and Vestry.*

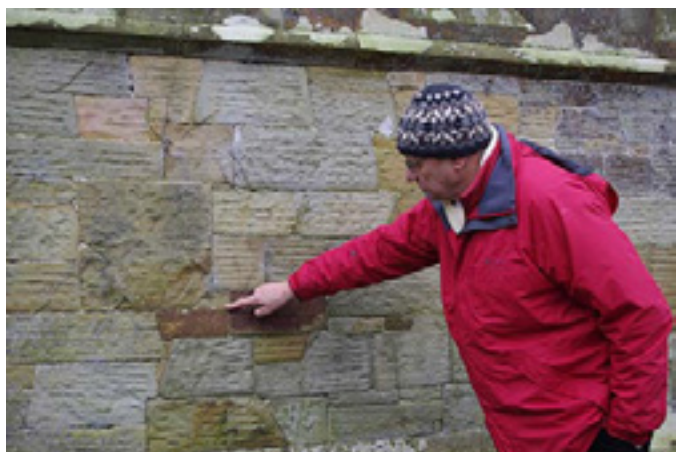
*Fig.2. (Middle left) Carefully shaped blocks of Pwntan Stone, St Michael's, Tremain.*

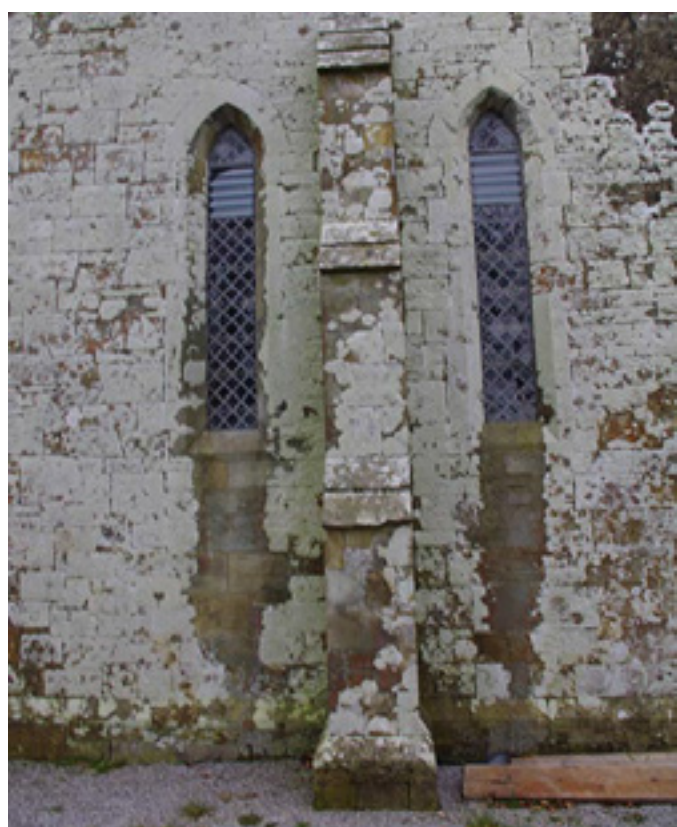
*Fig.3. (Above) Lead pollution exposing the stone in St Michael's Church, Tremain*

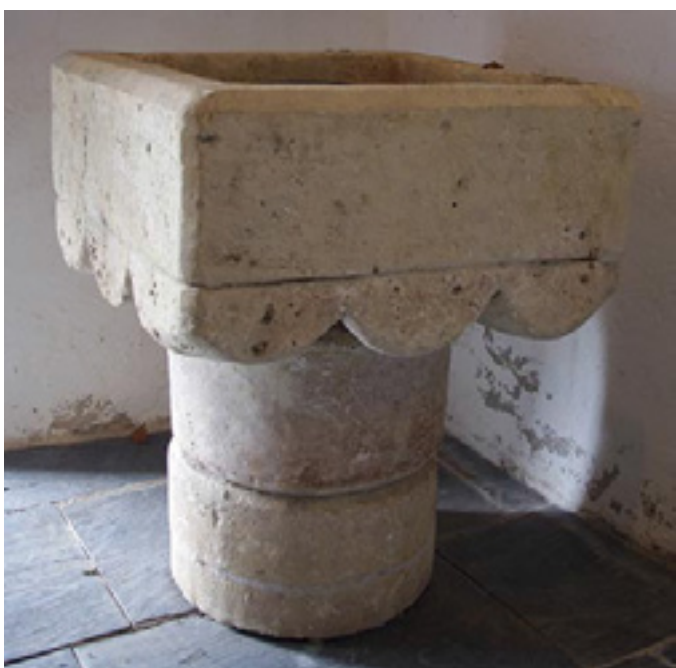
*Fig.4. (Bottom left) Dundry Stone medieval font, St Michael's, Penbryn*

Moving inside we found two fonts of note. In the porch is a mediaeval Romanesque-style font cut from Dundry Stone (Fig.4), which originally came from Cenarth, via Sarnau (Pevsner 2006). The second, also Romanesque, was thought to be Pwntan Stone possibly from the C12<sup>th</sup> or C13<sup>th</sup>. There are various places east of the main A487 where this sandstone was formerly extracted but most are long neglected and overgrown.

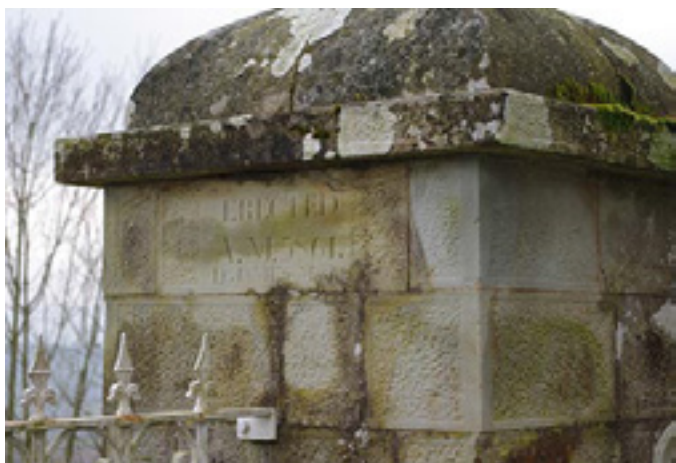
Fig.5. Pwntan Stone gate post, Bwlchbychan.

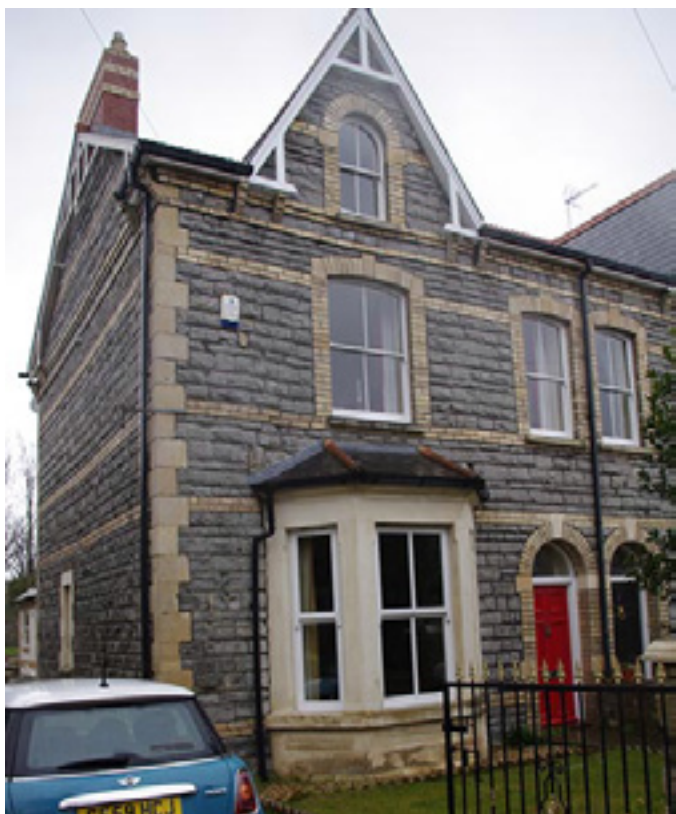
*Fig.1. A house of coursed Blue Lias limestone and bricks, Penarth.*

Walking out of town into a residential area we found a high limestone garden wall with many fossilised shells exposed. Nearby, large family houses had been built with coursed Lias limestone blocks with yellow bricks around the doors, upper windows and as decorative string courses (Fig.1). John explained that these bricks were made locally with the clay overburden found on top of the limestone. He said that the red bricks in the terrace across the road probably came from Cogan. A little further, Clive House has a garden wall built of blocks of granite. John explained that they could have come to Penarth as ballast in ships coming from the Baltic or even India as a lot of Welsh 'Steam' coal was exported there. The granite wall had a coping of Radyr Stone, a local red Triassic breccio-conglomerate, much used in and around Llandaff and north-west Cardiff. Blocks of this had also been used in the wall around the gateway.

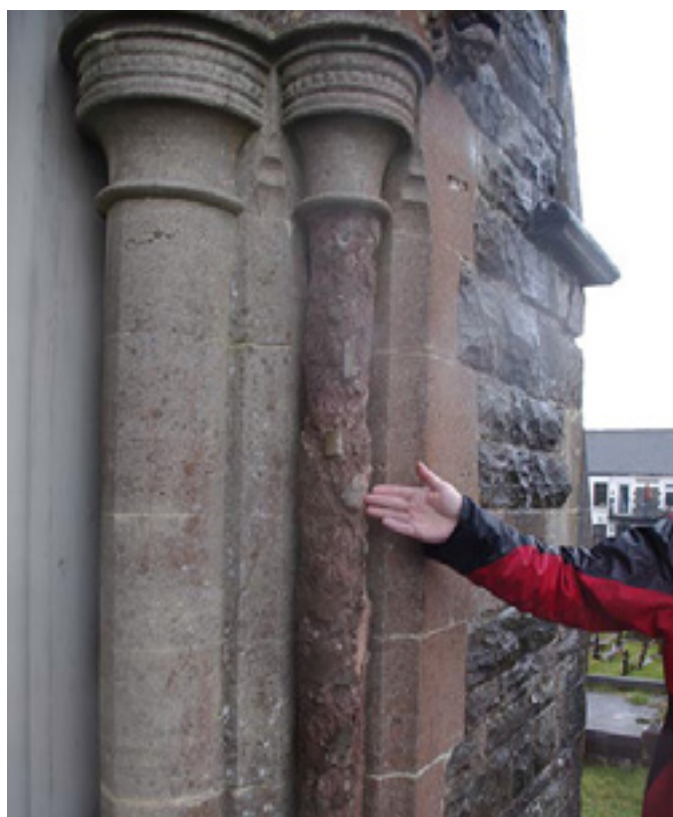
*Fig.2. Weathered columns of Radyr Stone, St Augustine's Church, Penarth*

Our next stop was St Augustine's Church. Designed by William Butterfield it was built between 1865 and 1866 to replace a small medieval church that was in poor condition and not large enough for the growing population thereabouts. Its walls are built of Lias limestones and the dressings of oolitic limestone. On both sides of the east door are decorative Radyr Stone columns, the soft stone of which has eroded badly over the past 150 years and the limestone clasts stand proud of the surface (Fig.2). These columns were one of the few decorative details to what is quite a plain exterior, especially compared to the highly decorated interior.

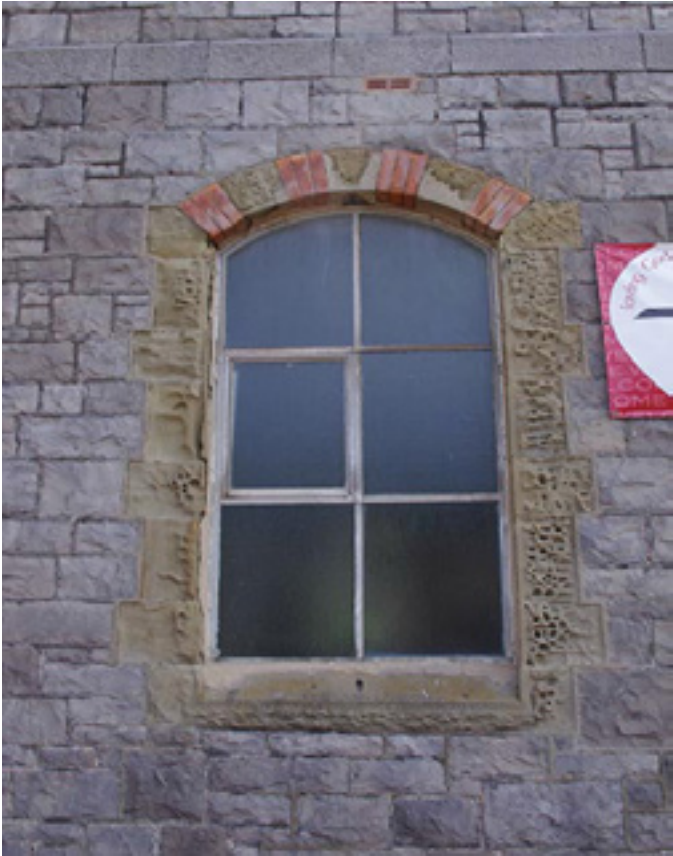
Fig.1. (Top left) Badly eroded Stone window dressings, Westgate Chapel, Pembroke.

Turning the corner onto Westgate Hill, Pembroke Castle towered above us. Solidly built in blocks of local limestone it dominates the town from its position on the western end of the ridge. Below, on the opposite side of the road to the castle, stands Westgate Chapel. It is also built of Carboniferous Limestone blocks but the window dressings are in sandstone, thought to be Cefn Stone, with a few decorative red brick voussoirs inserted. The sandstone dressings are badly eroded, the process probably accelerated by the use of cementitious mortar for repointing and stone repairs (Fig. 1).

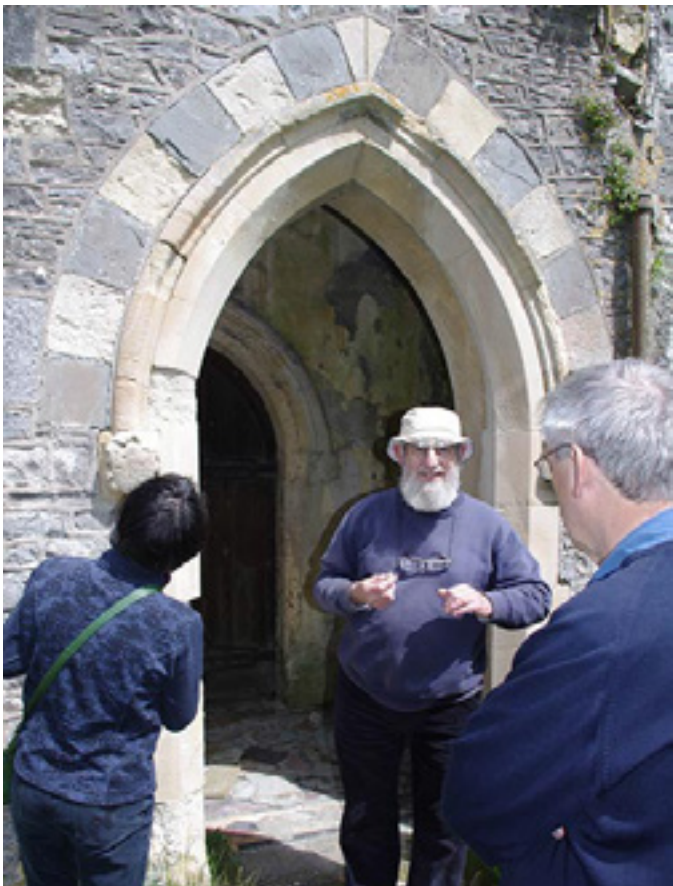
Fig.3. (Bottom left) Decorative use of limestones in the porch of St Michael's Church, Pembroke.

Nearby stands St Michael's Church. Originally built in the late C13<sup>th</sup> it was extensively rebuilt in 1832 but is now once more falling into disrepair. The building is mostly of Carboniferous Limestone rubble but the tower, which has been built in several stages, has a top of Carboniferous Limestone ashlar. These were probably inserted during the 1832 rebuild as in 1828 the tower was described as squat. The C19<sup>th</sup> dressings to the windows and doors are of Jurassic limestones, which have Gothic arches above in alternate Jurassic and Carboniferous limestone voussoirs for decorative effect (Fig.3). The slates on the roof were thought to have been quarried in Llangolman.

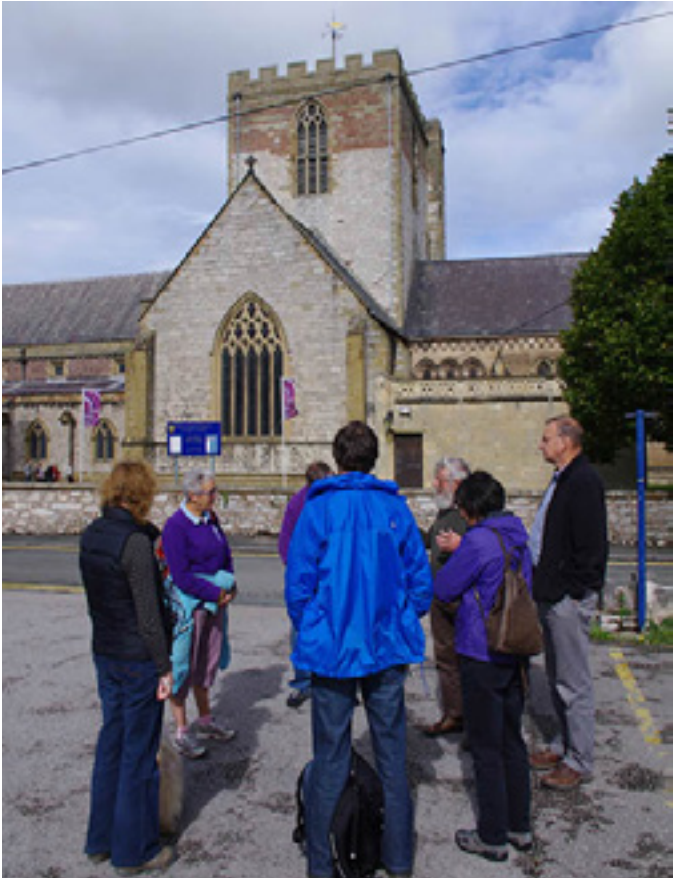
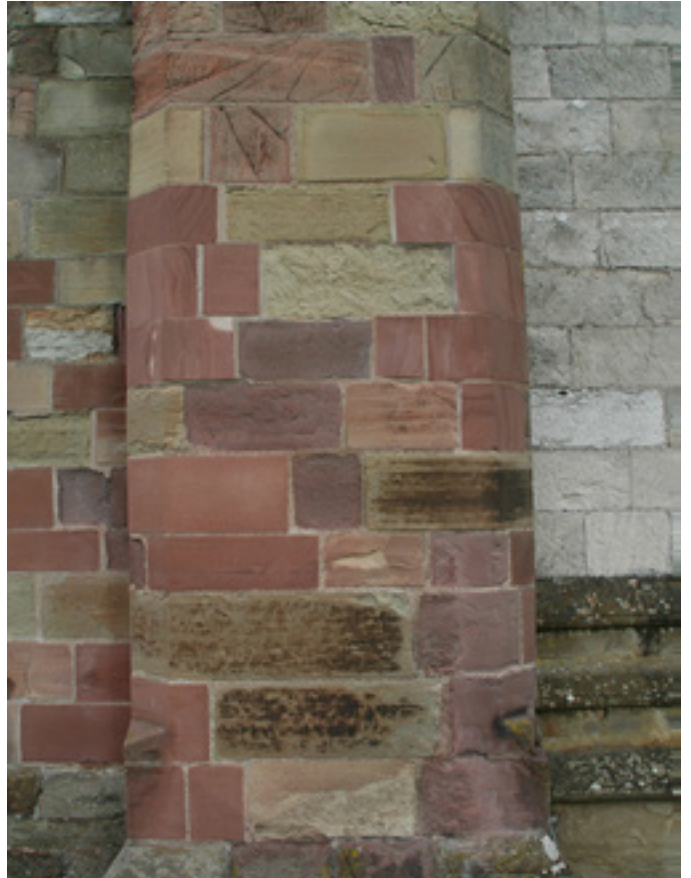
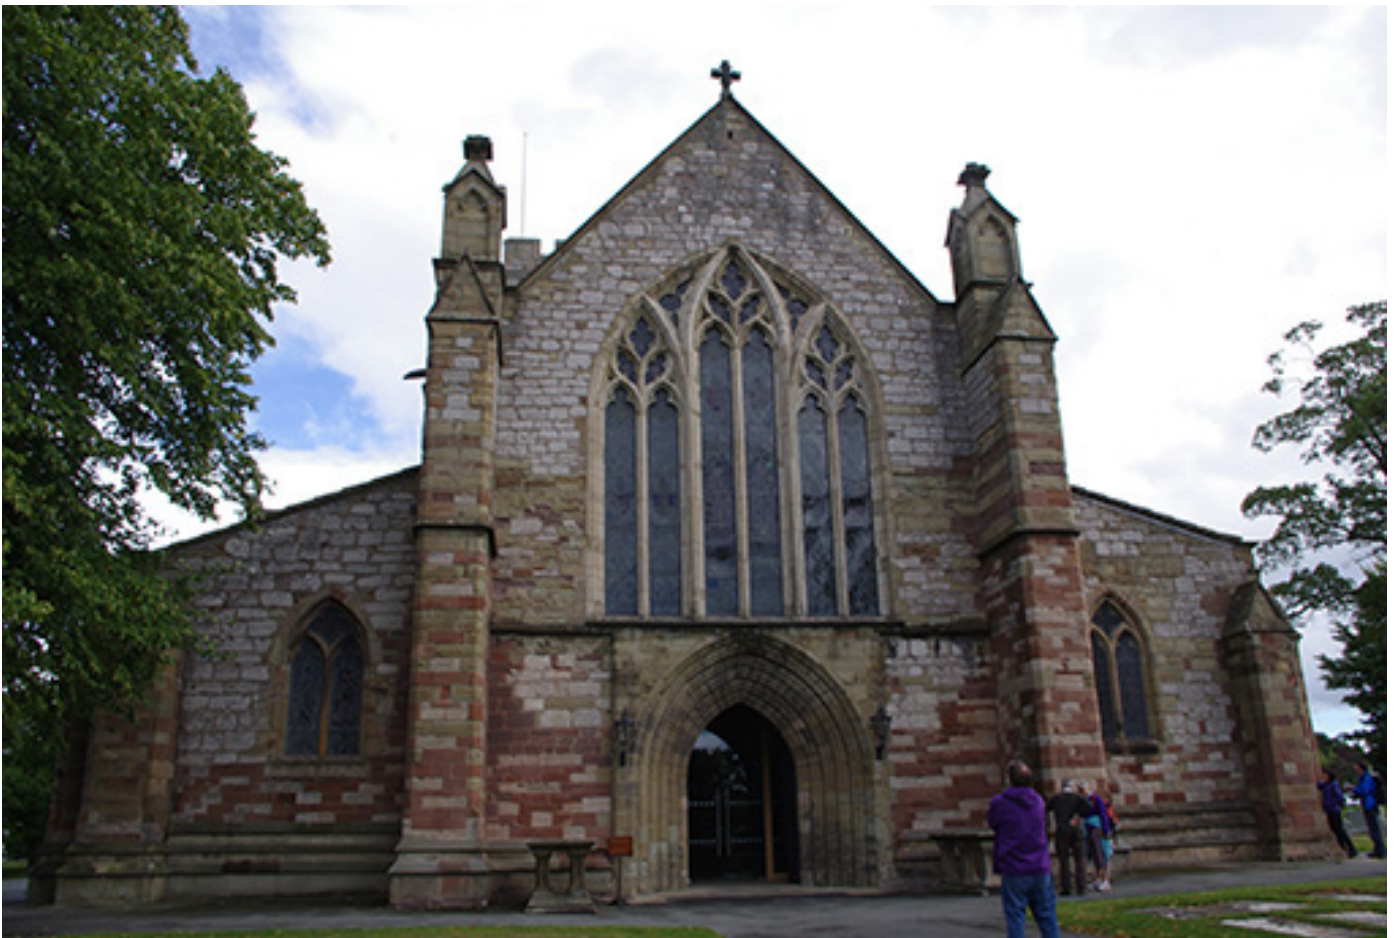
*Fig. 1. (Top left) St Asaph cathedral showing the tower repairs. Fig. 2a. (Top right) Close up of stone variety. Gwespyr Sandstone, purple Elwy Sandstone, Kinnerton Sandstone, red Hollington replacement and Carboniferous Limestone (right). Fig.2b. (Above) The west front of St Asaph cathedral.*

medieval period. Over the years there have been many replacements (Fig.2a & b), some in brick-red sandstone while other, more recent replacements, had the look of Hollington Sandstone from Staffordshire. To the right of the west door grey sandstone replacements in a string course, which contain visible coal spots, were thought to be Forest Pennant sandstone. Sandstone used in the base of the buttress (varying red to yellow in colour) had veins similar to those found in Grinshill Stone. However, after further field investigation, Andrew Haycock believes that this is a veined variety of stone from the local Kinnerton Sandstone Formation (Triassic).

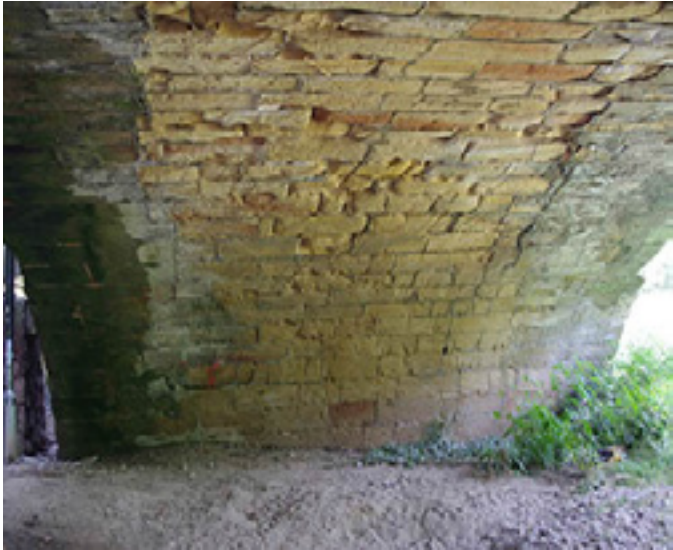
*Fig. 3a. (Top left) Weathered sandstone blocks under the C18th Town Bridge.*

Having arranged to meet Jim Hall at the Town Bridge spanning the River Elwy we moved on. Jim is the Engineer responsible for overseeing the repair and strengthening work to this C18<sup>th</sup> bridge. A combination of very heavy traffic, ingress of water laden with road salt and hard cementitious mortar used in earlier re-pointing and repairs has caused damage to the bridge that requires urgent attention. Many of the voussoir-shaped stone blocks have eroded to such an extent that the bridge arches are in danger of collapse so the repair entails selectively replacing these eroded elements with new.

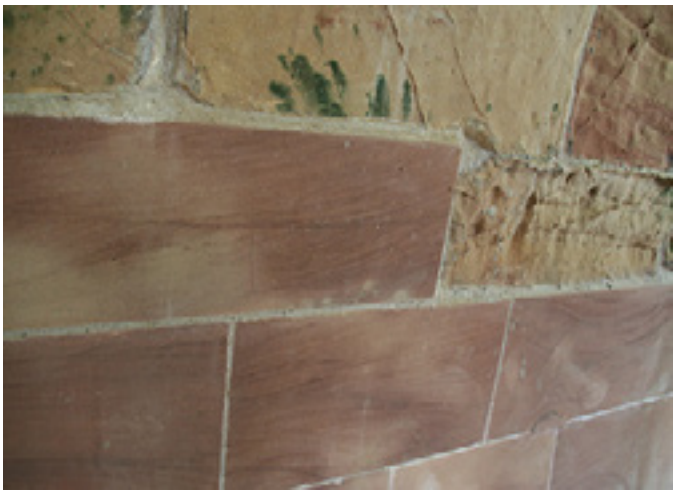
*Fig 3b. (Middle left) Close-up view of replacement blocks.*

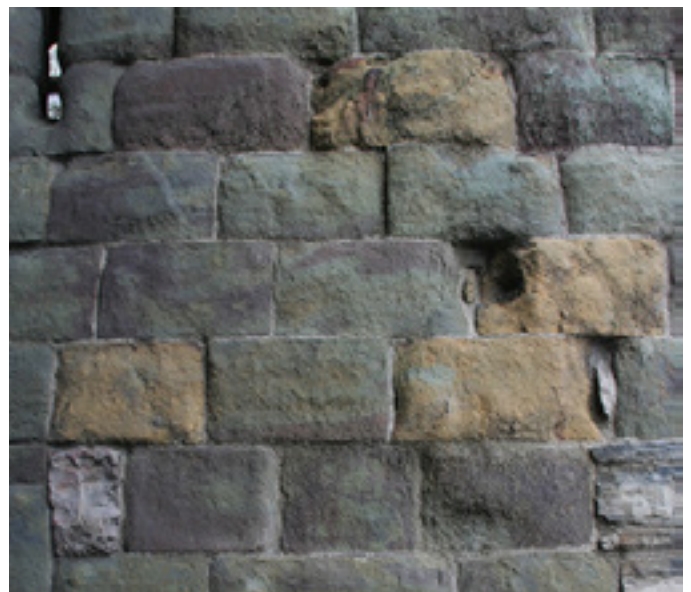
*Fig. 6. (Middle right) Close up view of mottled Carboniferous Basement Beds sandstone blocks.*

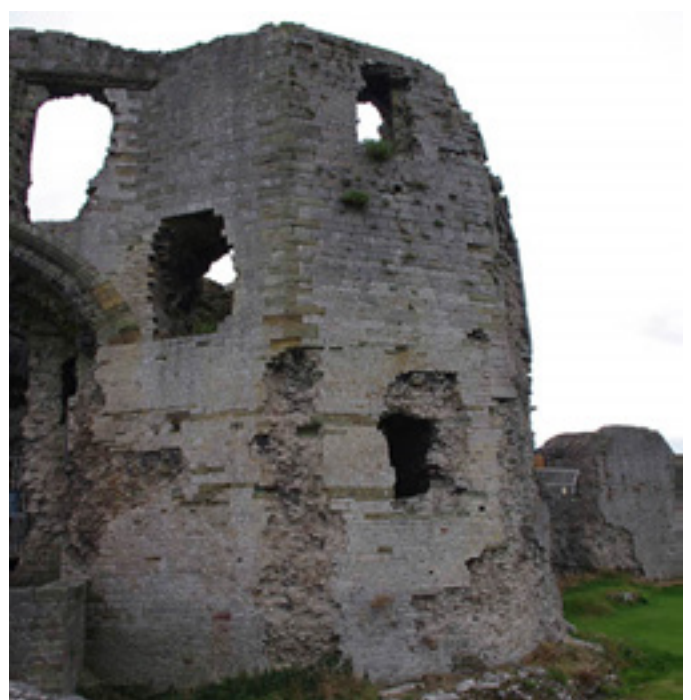
*Fig. 7. (Bottom right) The gate house at Denbigh Castle.*

We left the wall walk and made our way to Denbigh Castle. Looking at the front of the castle it was apparent that the masonry blocks in the base of the gatehouse towers were small compared to those towards the top (Fig.7). Some of us thought this was an odd method of construction but John Davies explained why - the first blocks of masonry out of a new quarry are often the smaller ones from the top beds, and it is these that would arrive on the construction site first. As the quarry was worked down the beds would generally get thicker and the blocks bigger. Castles were often built in a hurry and the builders could not wait until all the stone had been quarried so work started with what was to hand as it arrived on site; smallest first, larger later. Like the Burgess Gate the stone is predominantly Carboniferous Limestone with most dressings in a mottled yellow to grey/green sandstone. Sandstones of many different hues had been used in the core work.

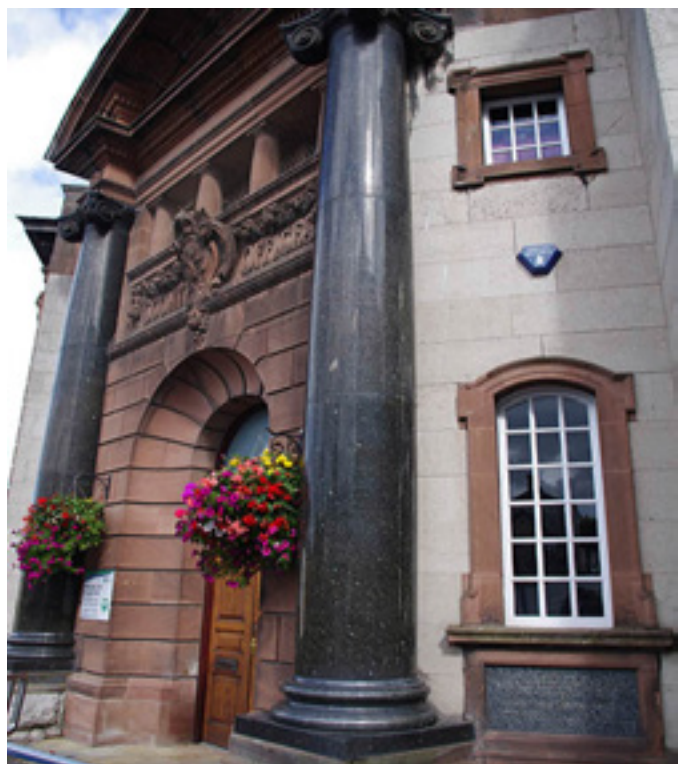
*Fig. 8. (Middle right) The entrance to the County Hall, Ruthin.*

We drove to Ruthin and following lunch walked into the town. Constructed with sawn blocks of nodular Carboniferous Limestone the County Hall has an entrance of red sandstone ashlar flanked by large columns of Larvikite from Norway (Fig.8). This dark igneous rock (augite-syenite) contains crystals of labradorite feldspar and is very popular on British high streets. The red sandstone has a regular colour and can be seen to have rounded grains, suggesting that it was aeolian (wind-blown) in origin rather than fluvial (laid down in water). Moving on, the Town Hall is predominantly constructed of three different stones; around the windows, doors and in miscellaneous dressings Cefn Stone has been used while much of the ground floor is of sawn blocks of Carboniferous Limestone but in the plinth below, and for the external elevation of upper floors, the builders have used a red/pink to grey sandstone, although some of the stone was veined, its appearance was different to the stone in St Asaph.

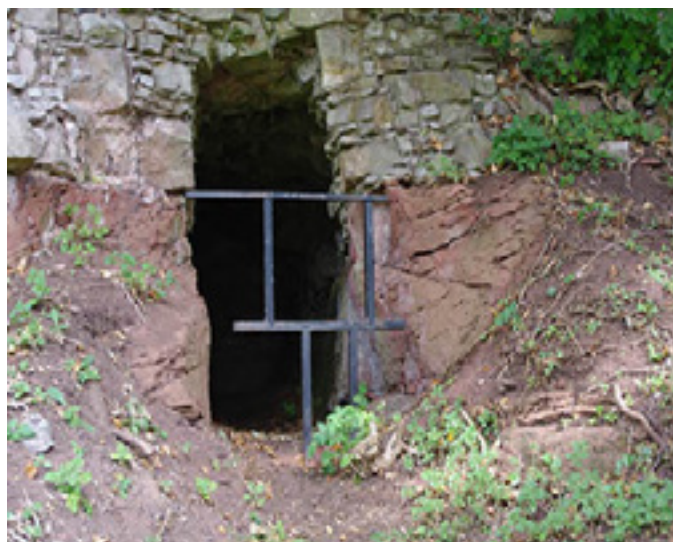
*Fig. 9. (Bottom right) The original castle ditch, now a tunnel, at the Ruthin Castle Hotel.*
